Extract from the annual report 2014
To the website: www.ist.fraunhofer.de/en.html

NEW MANUFACTURING APPROACH FOR ANTIFOULING COATINGS FOR PIPES

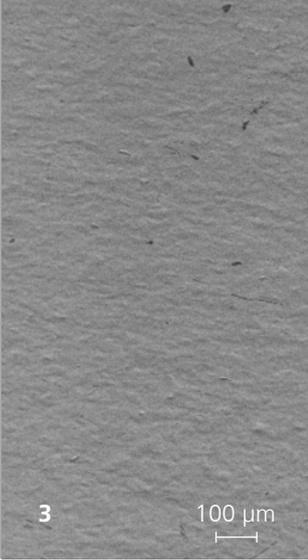
1 1 m long metal stripe with antifouling coating before roll-forming.

formed into pipes and welded (see sketch below). The coating must not suffer any damage during roll-forming of the pipes, its antifouling function must be guaranteed and it must have a high degree of durability. Currently pipes over a meter long can already be produced with an anti-fouling coating on the inside (Fig. 1). Appropriately adjusted PACVD processes mean that modified DLC coatings can be produced which remain entirely undamaged even with small pipe diameters (currently tested down to 12 mm) (Figs. 2 and 3).

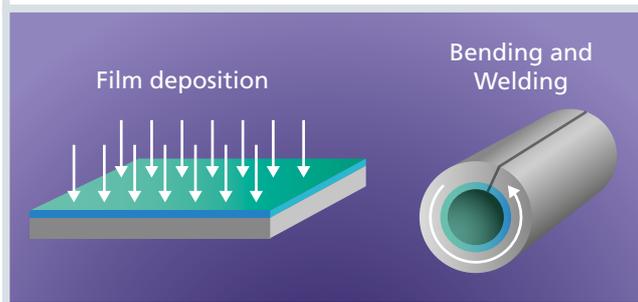
Manufacturing approach for pipes with an antifouling coating on the inner wall.

2-3 Different coating systems on the inside of the pipe after the forming process: (2) Standard DLC coating shows damage due to the pipe-forming process, (3) Modified DLC coating is fully intact and functional even after pipe forming.

A new approach to manufacturing has therefore been developed in collaboration with experts in forming and welding technologies. Here flat steel sheets are coated and then
